# **SUBERA'S PROGRESSIVE REHABILITATION AND CLOSURE PLAN**

Version 03

Document ID – Subera's PRCP

Date of Submission – February 2026

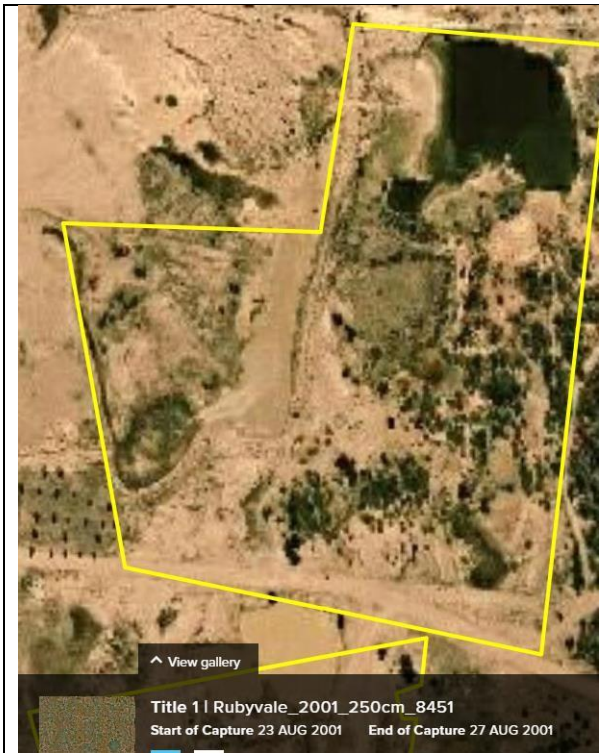
Figure 3: ML 72085 prior to grant

ML 70285 and ML 70286 on the Scrub Lead were granted on 5/11/2009. Records of the area disturbed during the period of the tenure have been kept by Fura Gems and are shown in the following figures. This area has been ripped and seeded with Fura Gems responsible for progressing this ripped and seeded rehabilitation through to the status of certified rehabilitation. Fura Gems is not responsible for the historical disturbance existing at the time of lease grant. Figure 3 and Figure 5 display the disturbance on the mining leases at lease grant with Figure 4 and Figure 6 showing current disturbance. The area mined to date by the current tenure holder on the two Scrub Lead mining leases has been rehabilitated (RM4). The elevated overburden dump is outside the area mined by Fura Gems. The current landform in the mined area of ML 70285 and ML 70286 has slopes of < 5%. Erosion rills are present in the rocky subsoil present on these leases. A shrub layer has established on ML 70285 with ground cover species establishing under the shrub cover. A similar process is expected in ML 70286. The company expects to obtain a rehabilitation standard equating to analogue sites on adjacent areas of the Scrub Lead, an area that continues to be disturbed by mining.

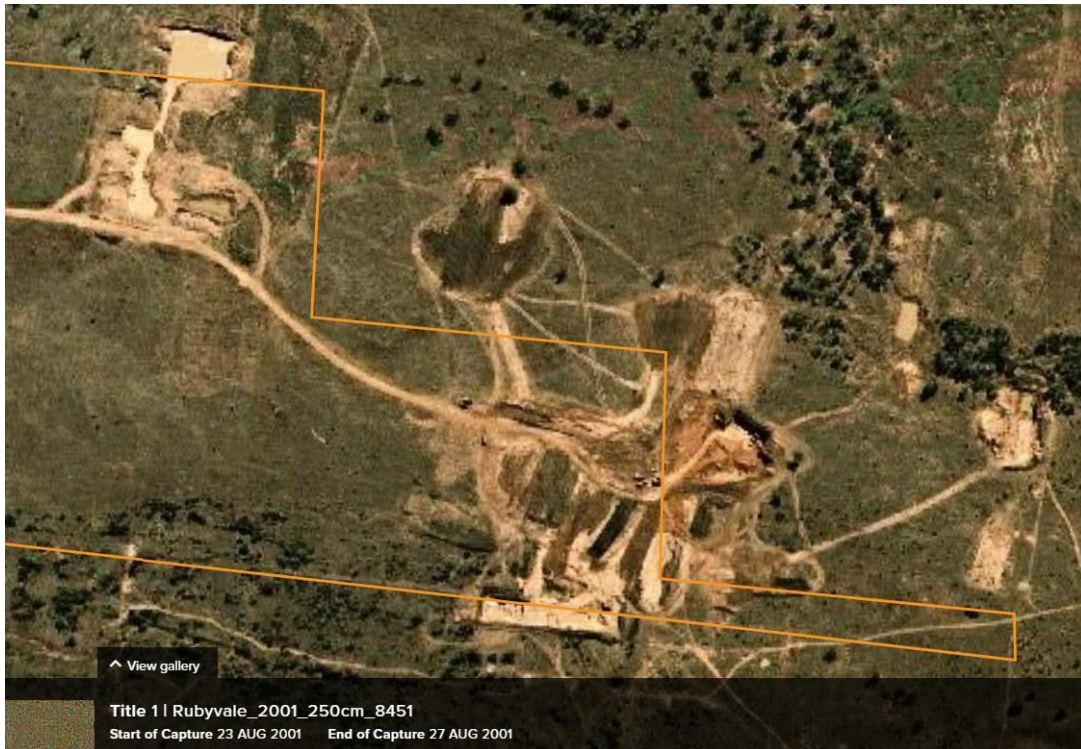
Figure 8: Historical Disturbance 2001 – Others

Historical disturbance on Subera is shown in Figure 8 to Figure 10. The disturbance of this mining extends into the current leases. Access to these mining areas can be observed to the west demonstrating that it was mined by others with a separate access. Figure 9 indicates that by 2012 the disturbance has been rehabilitated prior to relinquishment. Figure 10 is of a breached dam south of the industrial area. No records exist as to the timing of construction or the responsible party for the dam. Spatial data of the historical disturbance has been recorded from the 2001 mosaic in Qld Globe and from the current Google Earth image (see Figure 11).

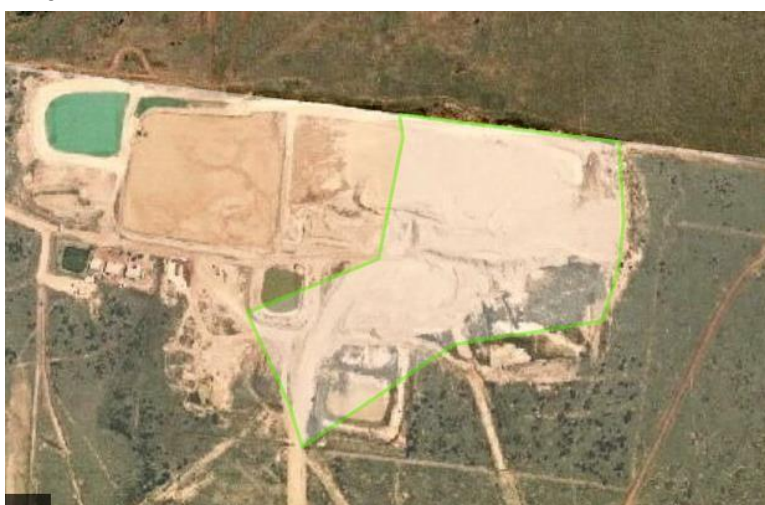
*Figure 12: Rejects Hill 2001*

Fura Gems has 2 certified rehabilitated domain that contained a Plant Area i.e. Rejects Hill and Lois Lane with its associated TSFs. Rejects Hill/Main Dam Site is an elevated Plant Area. Figure 12 shows the area in plan view in 2001. Green Polygon is the now certified rehabilitation of Rejects Hill. Figure 13 shows the area looking north-east in 2017.

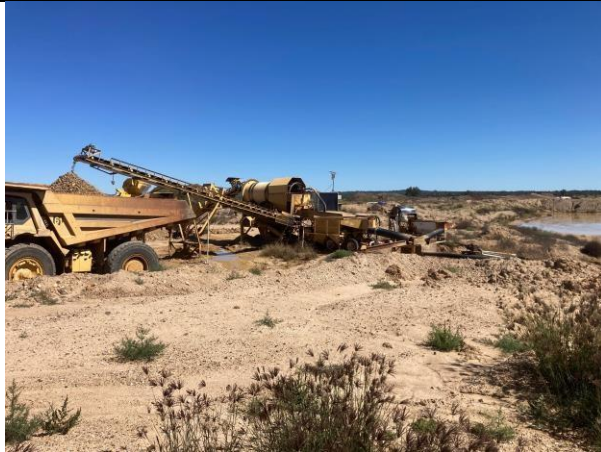
Figure 14: Wash Plant

The wash is hauled to a stockpile area and fed by a loader to a dry screening plant where up to 35% of the feed (oversize @ plus 18mm) is rejected being conveyed onto a truck (see Figure 15). This material is either returned to the mining pits by the trucks on their return journey or used for earthworks. The remaining 65% of sapphire bearing gravels is washed using a trommel and pulsator to a concentrate. No chemicals are used in the process. The waste stream flows by gravity onto the dry tails beach. The pipe is continuously moved to manage the beach and wet tails/return water flow. Dense rocks from the trommel and pulsator are collected in the base of the Plant. This material containing the sapphires is removed daily and further separated in the Industrial Area. Dense rocks are less than 0.01% of the wash tonnage with the sapphires are a similar percentage of the dense rocks.

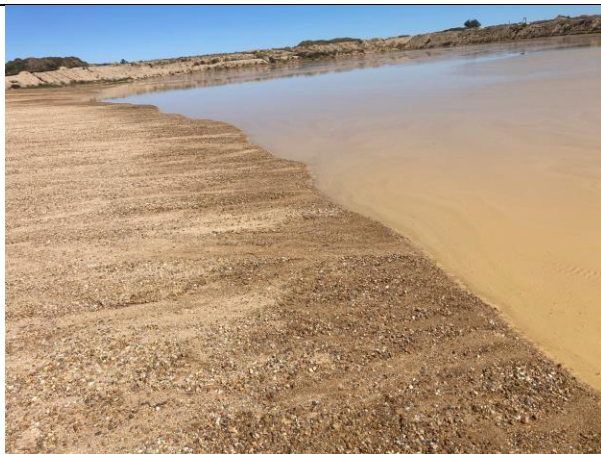
Figure 16: Dry tails beach

Dry tails deposit on an elevated beach with water and wet tails flowing off. The dry tails are sands and gravels and are trafficable immediately (see Figure 16). As the dry tails beach expands, the bund and the dry tails (Figure 17) can be removed maintaining a bund of dry tails to contain the return water and wet tails.

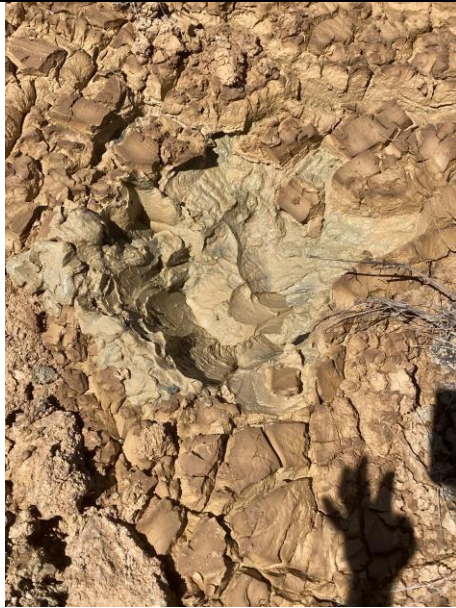
Figure 19: PL2 Wet Tails showing crusting

The wet tail's pH and salinity equate to TSF water quality (see Table 9). Water content of wet tails is high. Moisture content for Promised Land 2 wet tails which has been available for rehabilitation for 2 years is 70%. The wet tails surface rapidly crusts on drying (see Figure 19). Vegetation has established and grown on this pond (see Figure 20). Recent crowding of the wet tails has drowned the vegetation. Crowding and drying out of the wet tails take time and is the reason for the maximum of 5 years scheduled from a Plant Area being available to achieving RM2 i.e., final landform achieved. Fura Gems crews understand the nature of the wet tails and have successfully rehabilitated all wet tails to date with two Plant Areas achieving certified rehabilitation status in addition to two areas achieving RM4.

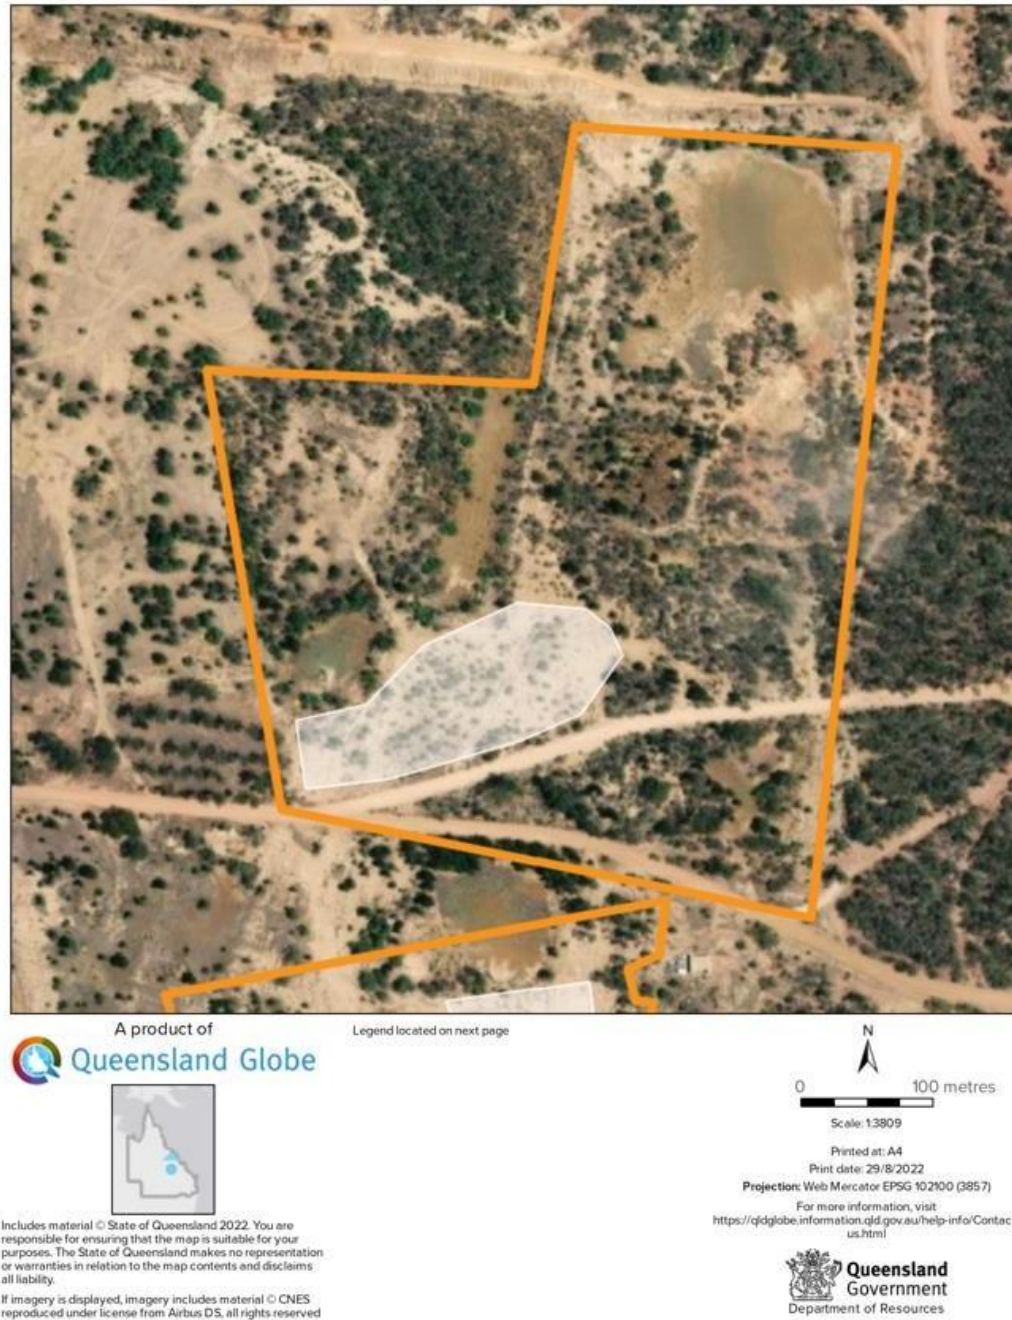
Figure 34: ML 72285

Legend: ML outline – orange; Fura Gems rehabilitation – shaded polygon

Fura Gems holds two MLs on the “Scrub Lead” Fossicker’s Area. ML 72085 (Figure 34) and ML 72086 (Figure 35) have been extensively mined prior to Fura Gems acquiring the leases. Figure 34 and Figure 35 shows the area mined by Fura Gems as a shaded polygon within the lease boundary.

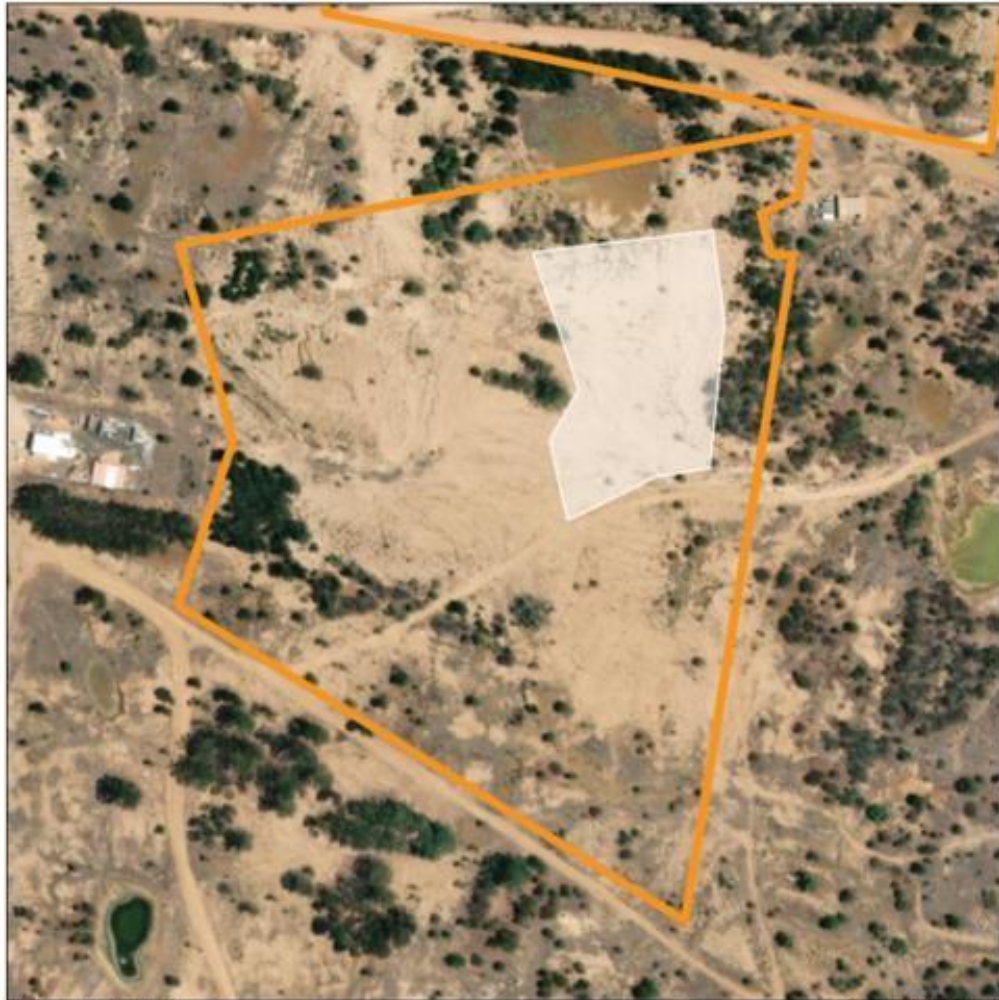
Figure 35: ML 70286

Legend: ML outline – orange; Fura Gems rehabilitation – shaded polygon
